Volume II-Problem Area Analysis

Luzerne County Act 167 Phase II

Stormwater Management Plan

June 30, 2010

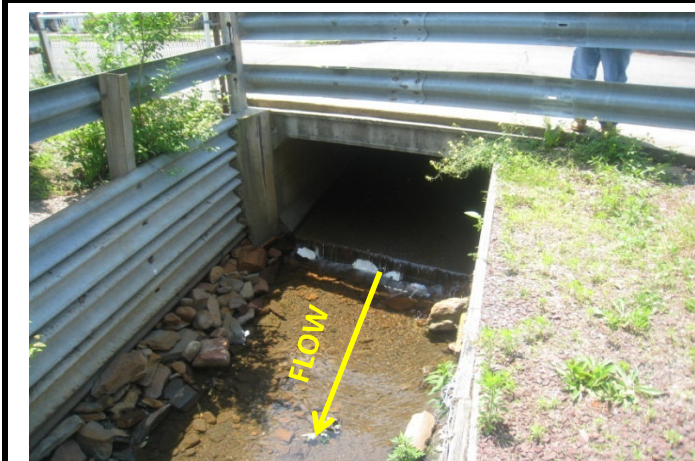
Problem Area - Map ID:	ASH001	Comments
Municipality:	Ashley Borough	The Conservation District reported flooding, streambank erosion, and a damaged foot bridge at the intersection of Sively and Preston Streets.
Subwatershed:	Solomon Creek	
Stream name:	Sugar Notch Run	
Inspected By/Date:	PAK 6/26/2009	
Checked By/Date:	Date: DEW 1/12/2010	
Type of Problem (highlighted):		
1	Flooding	
2	Deficient bridge/culvert	
3	Erosion	
4	Sedimentation	
5	Water/Groundwater Pollution	
6	Other

Downstream face of the culvert. This portion of the stream is channelized.

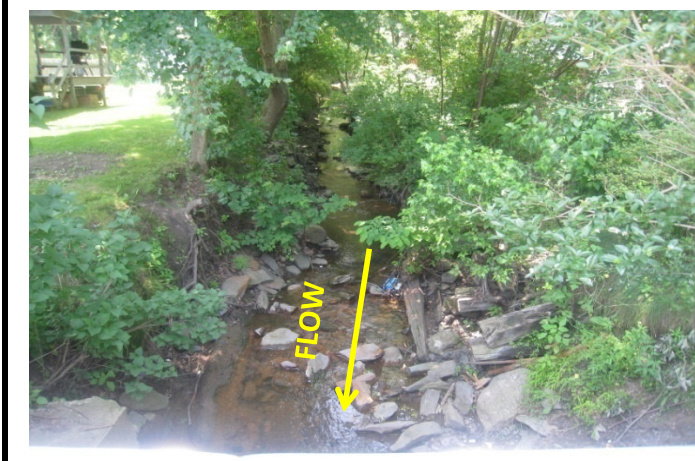
Looking upstream of the culvert. Streambank erosion can also be seen along the right bank.

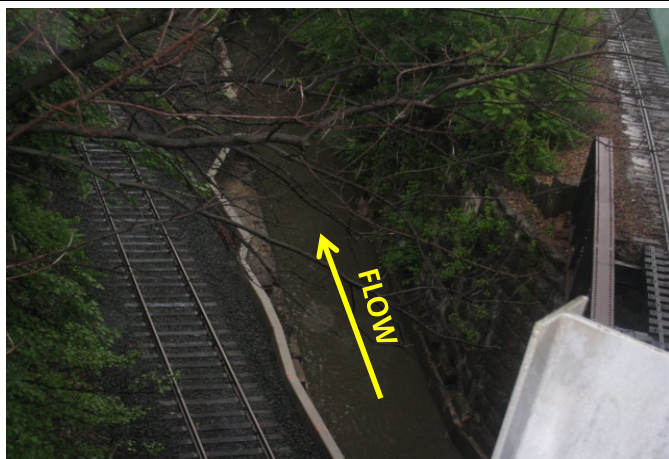
Problem Area - Map ID:	AVO002	Comments
Municipality:	Avoca Borough	Flooding was reported as a problem in this area by Avoca Borough. Based upon field observations, the channelization of Mill Creek under the railroad bridge may cause upstream flooding due to the restriction.
Subwatershed:	Mill Creek	
Stream name:	Mill Creek	
Inspected By/Date:	PAK 6/18/2009	
Checked By/Date:	DEW 1/7/2010	
Type of Problem (highlighted):		
1	Flooding	
2	Deficient bridge/culvert	
3	Erosion	
4	Sedimentation	
5	Water/Groundwater Pollution	
6	Other

Description
Looking down from the SR 11 bridge at the railroad bridge and tracks on each side of the creek. Channelization of the creek is shown along the left bank. Stream flows from large storm events could overtop the flood walls.

Solution	6.7.1, 6.A, 6.B
----------	-----------------

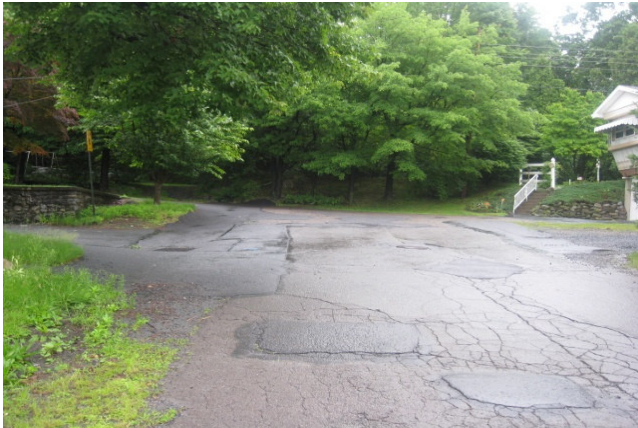
Problem Area - Map ID:	AVO006	Comments
Municipality:	Avoca Borough	Flooding, sedimentation, and groundwater were reported as problems in this area by Avoca Borough. Reportedly, stormwater runoff from I-81, which runs perpendicular to the eastern end of McAlpine Street, is causing the flooding.
Subwatershed:	Mill Creek	
Stream name:	Local Drainage	
Inspected By/Date:	PAK 6/18/2009	
Checked By/Date:		
Type of Problem (Highlighted):		
1	Flooding	
2	Deficient bridge/culvert	
3	Erosion	
4	Sedimentation	
5	Water/Groundwater Pollution	
6	Other

<div style="width: 50%; padding-left: 10px;"> <p>Area of McAlpine Street that experiences flooding problems.</p> </div> </div>

Solution	6.4.4, 6.4.10, 6.A, 6.D, 6.E
----------	------------------------------

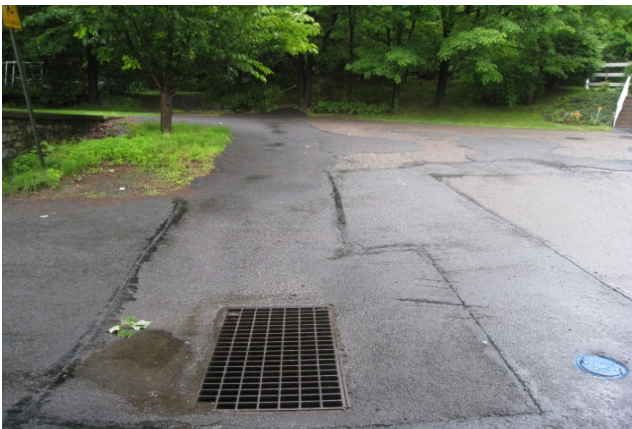
<div style="width: 50%; padding-left: 10px;"> <p>Storm drain on McAlpine Street.</p> </div> </div>

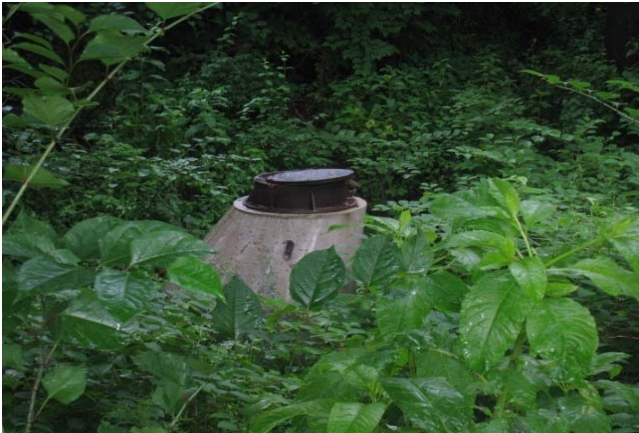
Problem Area - Map ID:	AVO007	Comments
Municipality:	Avoca Borough	Flooding, sedimentation, and water pollution were reported as problems in this area by Avoca Borough. Access to the property was restricted and these problems could were not observed.
Subwatershed:	Mill Creek	
Stream name:	Local Drainage	
Inspected By/Date:	PAK 6/18/2009	
Checked By/Date:	DEW 1/7/2010	
Type of Problem (Highlighted):		
1	Flooding	
2	Deficient bridge/culvert	
3	Erosion	
4	Sedimentation	
5	Water/Groundwater Pollution	
6	Other

Description
	Manhole for combination sewer system located next to the railroad tracks.

Solution	Further investigation required due to access restriction
----------	--

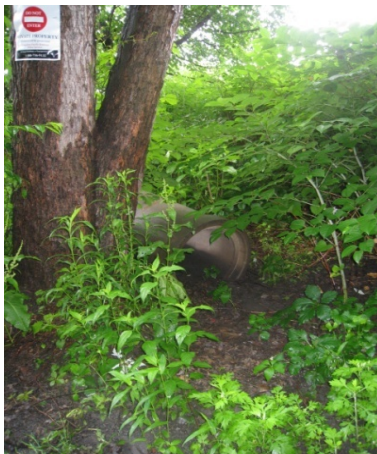
Description
	RCP culvert aligned parallel to the railroad.

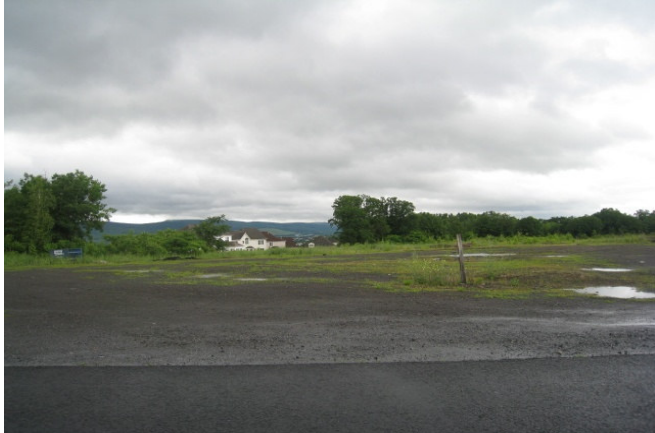
Problem Area - Map ID:	AVO008 and AVO010	Comments
Municipality:	Avoca Borough	This problem area was reported by Avoca Borough. According to forms received by the Borough, stormwater management issues at the Quail Hill Development site are causing flooding and sedimentation problems for the downstream residents on Geddings Street, Pittston Avenue, and Packer Avenue.
Subwatershed:	Mill Creek	
Stream name:	Local Drainage	
Inspected By/Date:	PAK 6/18/2009	
Checked By/Date:	DEW 1/7/2010	
Type of Problem (Highlighted):		
1	Flooding	
2	Deficient bridge/culvert	
3	Erosion	
4	Sedimentation	
5	Water/Groundwater Pollution	
6	Other

Description
	This residential development is currently in the construction phase. An empty lot is shown in this photo. Development on other tracts is ongoing and there appeared to be minimal E & S controls in place.

Solution	6.4.10, 6.6.2, 6.4.5, 6.A, 6.D
----------	--------------------------------

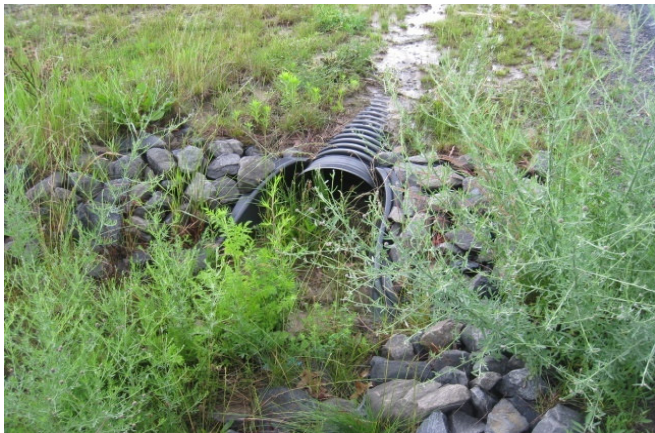
Description
	Constructed stormwater conveyance piping and rock lined swales. Stormwater management basin(s), which is expected for this type of development, could not be located.

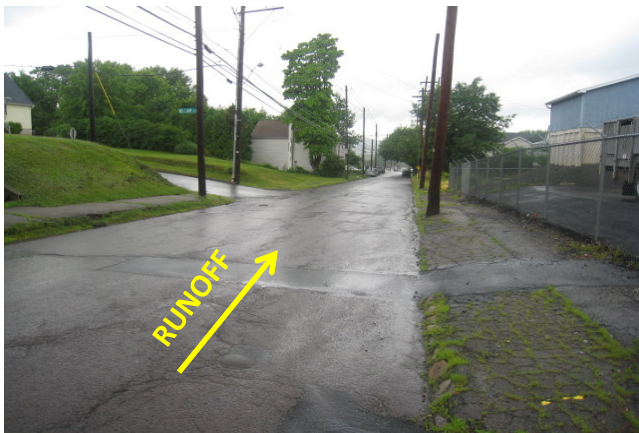
Problem Area - Map ID:	AVO009	Comments
Municipality:	Avoca Borough	Flooding and groundwater problems in this area were reported by Avoca Borough. Reportedly, flooding is caused by stormwater runoff from the nearby I-81 and mine water surfacing.
Subwatershed:	Mill Creek	
Stream name:	Local Drainage	
Inspected By/Date:	PAK 6/18/2009	
Checked By/Date:	DEW 1/7/2010	
Type of Problem (Highlighted):		
1	Flooding	
2	Deficient bridge/culvert	
3	Erosion	
4	Sedimentation	
5	Water/Groundwater Pollution	
6	Other

</div> <div style="width: 50%; padding-left: 10px;"> <p>Intersection of Plane and Williams Streets. The Municipal Borough Maintenance Garage is on the right. No stormwater collection and conveyance systems are visible.</p> </div>

Solution	6.4.5 in playground area, 6.A, 6.C, 6.D
----------	---

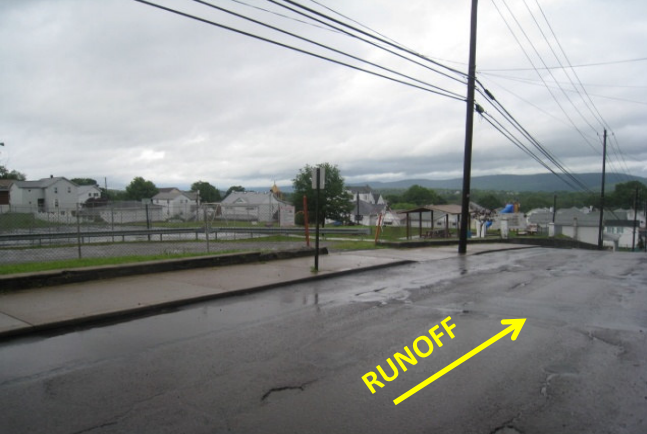
</div> <div style="width: 50%; padding-left: 10px;"> <p>A supervisor at the Municipal Maintenance Garage indicated that stormwater travels down Plane Street and that areas around the playground (shown in the photo) frequently flooded and partially eroded. Curbing was installed in the park to prevent stormwater from flowing onto the sidewalk and prevent erosion.</p> </div>

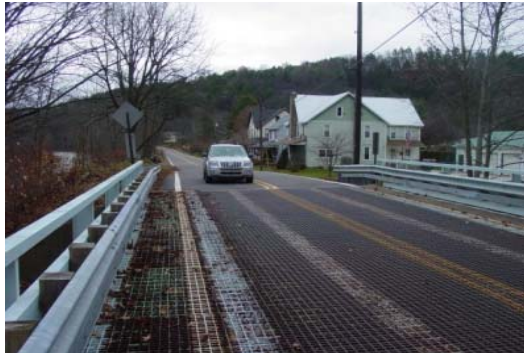
Problem Area ID:	BCR001	Inspected By/Date:	PAD 11/12/2080
Municipality:	Black Creek Township	Checked By/Date:	DEW 2/4/2010
Subwatershed:	Nescopeck Watershed

Explanation: The Conservation District notes in the problem area worksheet that the channel at the upstream face of the bridge became clogged with sediment. Based upon site observations, the problem looks to be the bridge over Black Creek. Options for correcting this condition include maintenance to remove accumulated sediment and replacing the bridge with a structure with an appropriate hydraulic opening.

Stream name:	Black Creek		
Drainage Area (mi ²):	61.8		
Calculation Method:	NSS StreamStats		
C (Tc):	N/A (N/A)		
Storm Frequency (Yrs)	Rainfall (in)	Peak Discharge (cfs)	Unit Discharge (cfs/Ac)
2	N/A	2,290	0.06
5	N/A	3,820	0.10
10	N/A	5,050	0.13
50	N/A	8,310	0.21
100	N/A	9,940	0.25
500	N/A	14,400	0.36
*Type of Problem (Highlight all that apply):		Description	
Flooding	Deficient Bridge/Culvert	Rocks and sediment from mountain filled a collection basin & culvert causing flooding; blocked storm drain cleaned by property owner to prevent flooding of driveway.	
Erosion	Sedimentation		
Water/Groundwater Pollution	Other		
Potential Solutions			
<p>The Tank Road Bridge has been identified as a problem area by the Conservation District due to a history of debris accumulation, sedimentation, and upstream flooding. Based upon general field observations, this problem is believed to be caused by too small of a hydraulic opening, bridge span low chords below flood elevation, and/or accumulation of sediment and debris causing an obstruction to flow. Possible solutions to this problem are A) removing sediment reducing blocking the hydraulic opening and B) providing more frequent maintenance activities.</p>

Cost Estimates			
Option	A	B	C
Cost Range	\$1,000-\$10,000	\$1,000-\$5,000/year	N/A

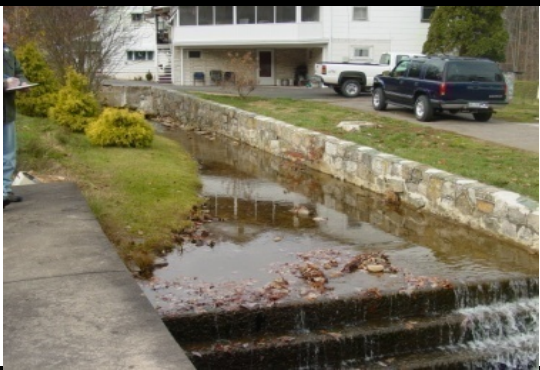
Problem Area ID:	BCR003	Inspected By/Date:	PAD 11/12/2080
Municipality:	Black Creek Township	Checked By/Date:	DEW 2/4/2010
Subwatershed:	Nescopeck Watershed

Stream name:	Trib to Black Creek		
Drainage Area (mi ²)	1.81		
Calculation Method	NSS StreamStats		
C (Tc)	N/A (N/A)		
Storm Frequency (Yrs)	Rainfall (in)	Peak Discharge (cfs)	Unit Discharge (cfs/Ac)
2	3.16	164	0.14
5	3.91	226	0.20
10	4.57	272	0.23
50	6.53	514	0.44
100	7.63	652	0.56
500	10.98	1,070	0.92
*Type of Problem (Highlight all that apply):		Description	
Flooding	Deficient Bridge/Culvert	TConservation District reported relocated stream channel, bridge may have been blocked which redirected flow across Mtn. Road and down driveways during June 2006 flood. Property damage including 1.5' of water on first floor of adjacent residence. Site Visit: Creek overflows into backyard; deficient size bridge; steps at bottom undermined by scour hole; channelized stream; erosion and flooding problems.

Erosion	Sedimentation		
Water/Groundwater Pollution	Other		
Potential Solutions			
<p>Repeated flooding in Rock Glen has been identified by the Conservation District. Based upon general field observations, this problem is believed to be caused by structures constructed in floodplain with floor elevation below flood elevation and channelization of the tributary which has resulted in flood damage. Possible solutions to this problem are A) construction of a regional basin upstream, B) raise or apply flood proofing measure to structures, or C) remove structures in the floodplain and reestablish a stream buffer.</p>			
Cost Estimates			
Option	A	B	C
Cost Range	further invest. req'd	further invest. req'd	further invest. req'd

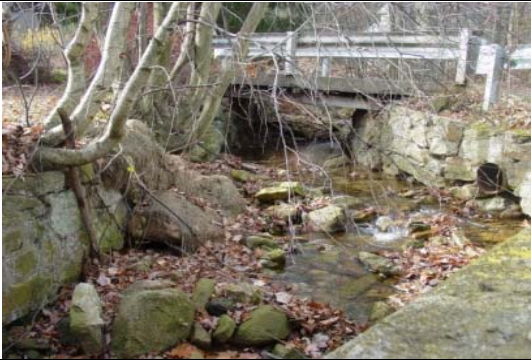
Problem Area ID:	BCR004	Inspected By/Date:	PAK 12/3/2008
Municipality:	Black Creek Township	Checked By/Date:	DEW 2/4/2010
Subwatershed:	Nescopeck Watershed

Stream name:	Trib to Black Creek		
Drainage Area (mi ²):	1.81		
Calculation Method:	NSS StreamStats		
C (Tc):	N/A (N/A)		
Storm Frequency (Yrs)	Rainfall (in)	Peak Discharge (cfs)	Unit Discharge (cfs/Ac)
2	3.16	164	0.14
5	3.91	226	0.20
10	4.57	271	0.23
50	6.53	513	0.44
100	7.63	651	0.56
500	10.98	1,070	0.92
*Type of Problem (Highlight all that apply):		Description	
Flooding	Deficient Bridge/Culvert	Conservation District reported overflow of tributary into backyard of adjacent properties and basement flooding of up to 4 feet. Site visit: Deficient size bridge; sediment buildup under bridge.	
Erosion	Sedimentation		
Water/Groundwater Pollution	Other		
Potential Solutions			
Repeated flooding in Rock Glen has been identified by the Conservation District. Based on field observations, this problem is believed to be caused by structures constructed in the floodplain with floor elevation below flood elevation and restrictions created by a deficient bridge. Possible solutions to these problems are A) replace the bridge with a properly sized structure, B) raise or apply flooding proof measure to structures, or C) remove structures the floodplain and reestablish a stream buffer.

Cost Estimates			
Option	A	B	C
Cost Range	further invest. req'd	further invest. req'd	further invest. req'd

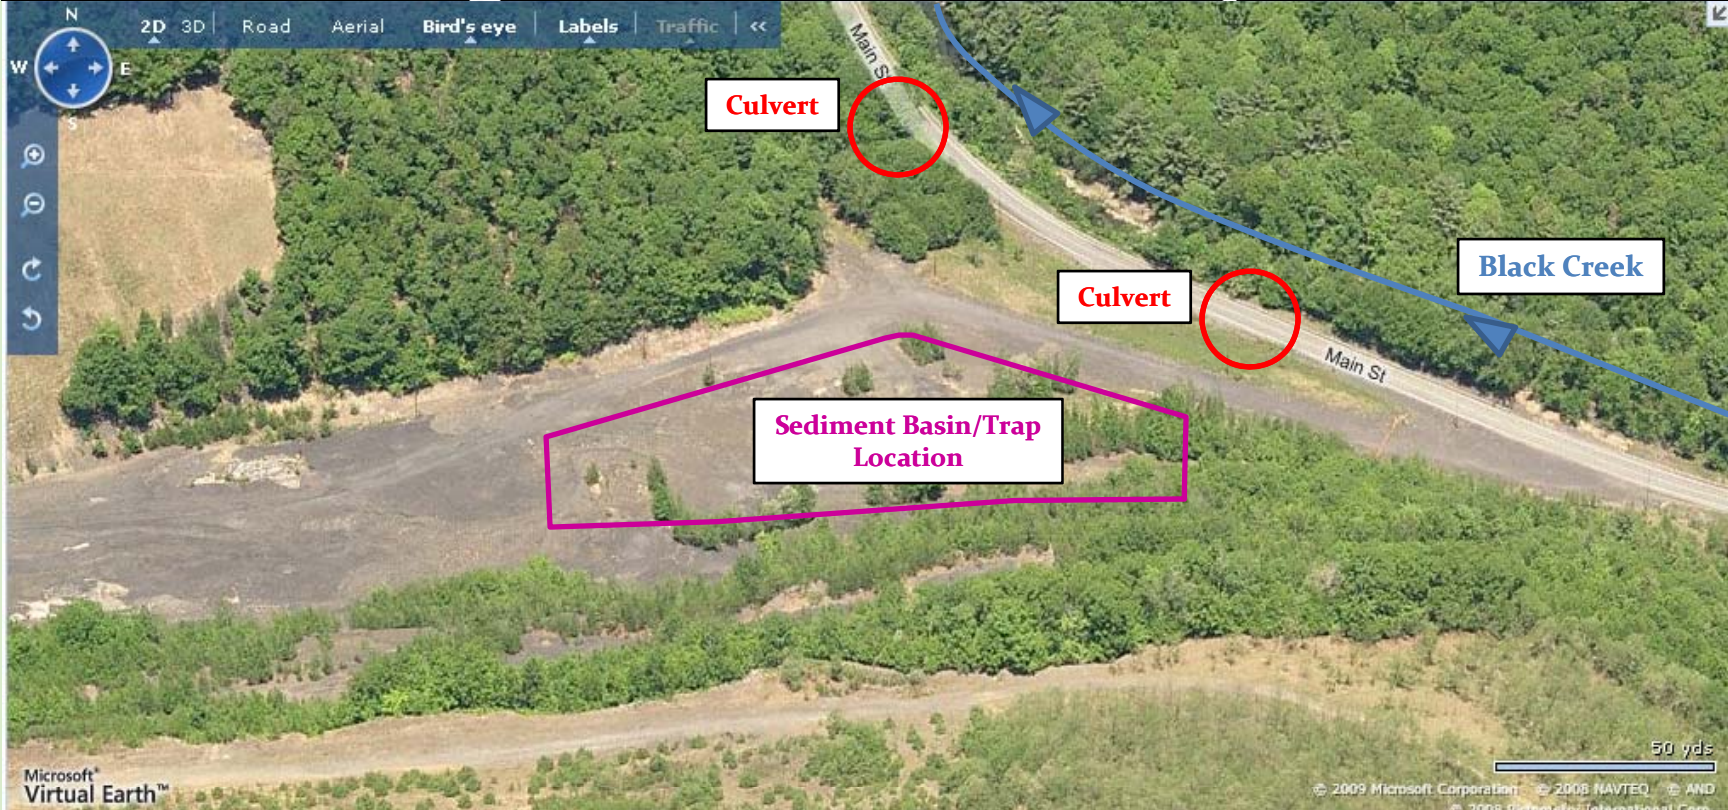
Problem Area	Municipality	Sub Watershed	Stream Name	Preferred Solution
BCR005	Black Creek Twp	Nescopeak	Swale to Black Creek	Proposed Solution: (A)

Explanation: This is the location of a former strip mine. Stormwater travels down gradient across unstabilized soil causing erosion. Sediment is deposited in downstream areas causing impacts including a blocked culvert.

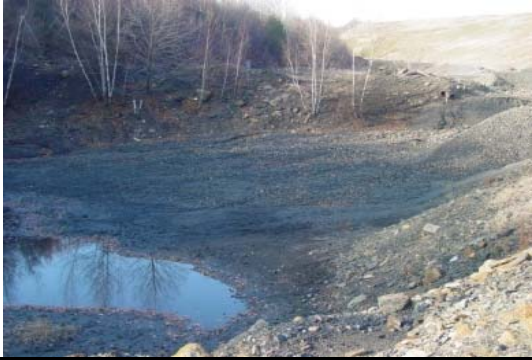
Problem Area ID:	BCR005	Inspected By/Date:	PAD 11/12/2008
Municipality:	Black Creek Township	Checked By/Date:	DEW 2/4/2010
Subwatershed:	Nescopeck Watershed

Stream name:	Trib to Black Creek		
Drainage Area (mi ²):	3.56		
Calculation Method:	USGS 2000-4189		
C (Tc):	N/A (N/A)		
Storm Frequency (Yrs)	Rainfall (in)	Peak Discharge (cfs)	Unit Discharge (cfs/Ac)
2	N/A	313	0.14
5	N/A	428	0.19
10	N/A	520	0.23
50	N/A	972	0.43
100	N/A	1,228	0.54
500	N/A	2,006	0.88
*Type of Problem (Highlight all that apply):		Description	
Flooding	Deficient Bridge/Culvert	Property is adjacent to an abandoned mine. Uncontrolled runoff crossing unvegetated land appears to be causing erosion and downstream sedimentation. A culvert to the east of the site has become clogged with sediment.	
Erosion	Sedimentation		
Water/Groundwater Pollution	Other		
Potential Solutions			
<p>Prior strip mining activity at the Yamulla Property has been identified as the cause of stormwater problems by the Conservation District. Based upon general field observations, stormwater problems at this location include increased runoff rate and volume caused by unvegetated bare-soil conditions. Additional impacts include soil erosion, sediment laden runoff entering waterways, and clogging of a downstream culvert. Possible solutions to this problem include A) drainage control with stabilized swales and sediment traps/basins, B) reclaiming the mine by establishing vegetative cover or C) annual maint. to remove sediment.</p>

Cost Estimates			
Option	A	B	C
Cost Range	\$100,000-\$250,000	\$1,000,000-\$4,000,000	\$2,000/year

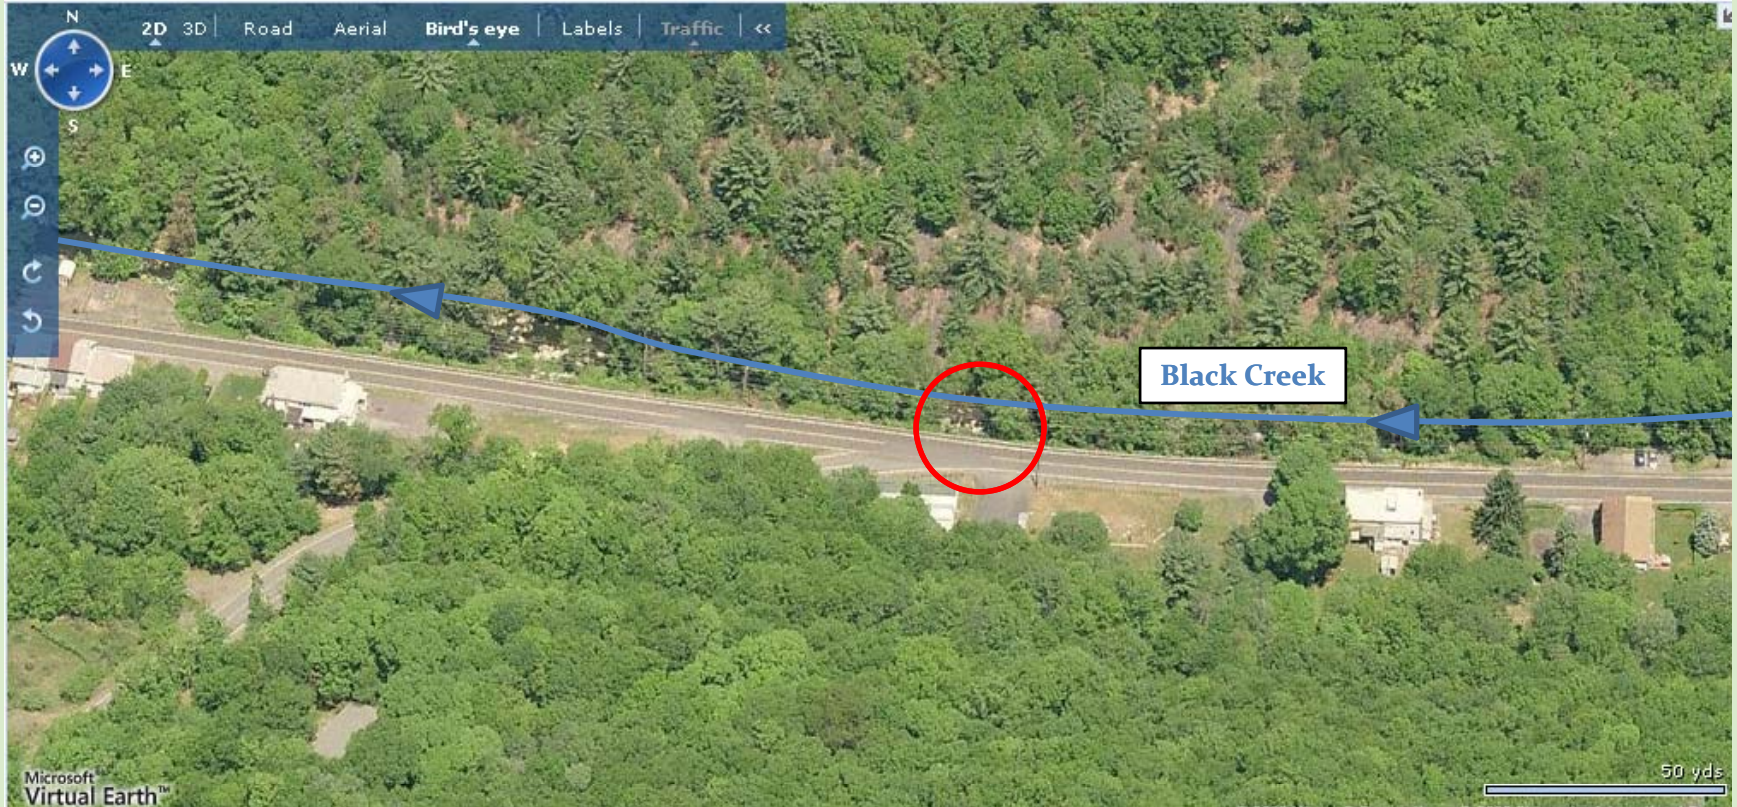
Problem Area	Municipality	Sub Watershed	Stream Name	Preferred Solution
BCRoo6	Black Creek Twp	Nescopeck	Black Creek	Proposed Solution (A)

Explanation: The Luzerne Conservation District reports that a collapsed mine has caused significant erosion leading to property loss. Options for correction involve armoring the banks with riprap and placement of natural vegetation to stabilize the banks.

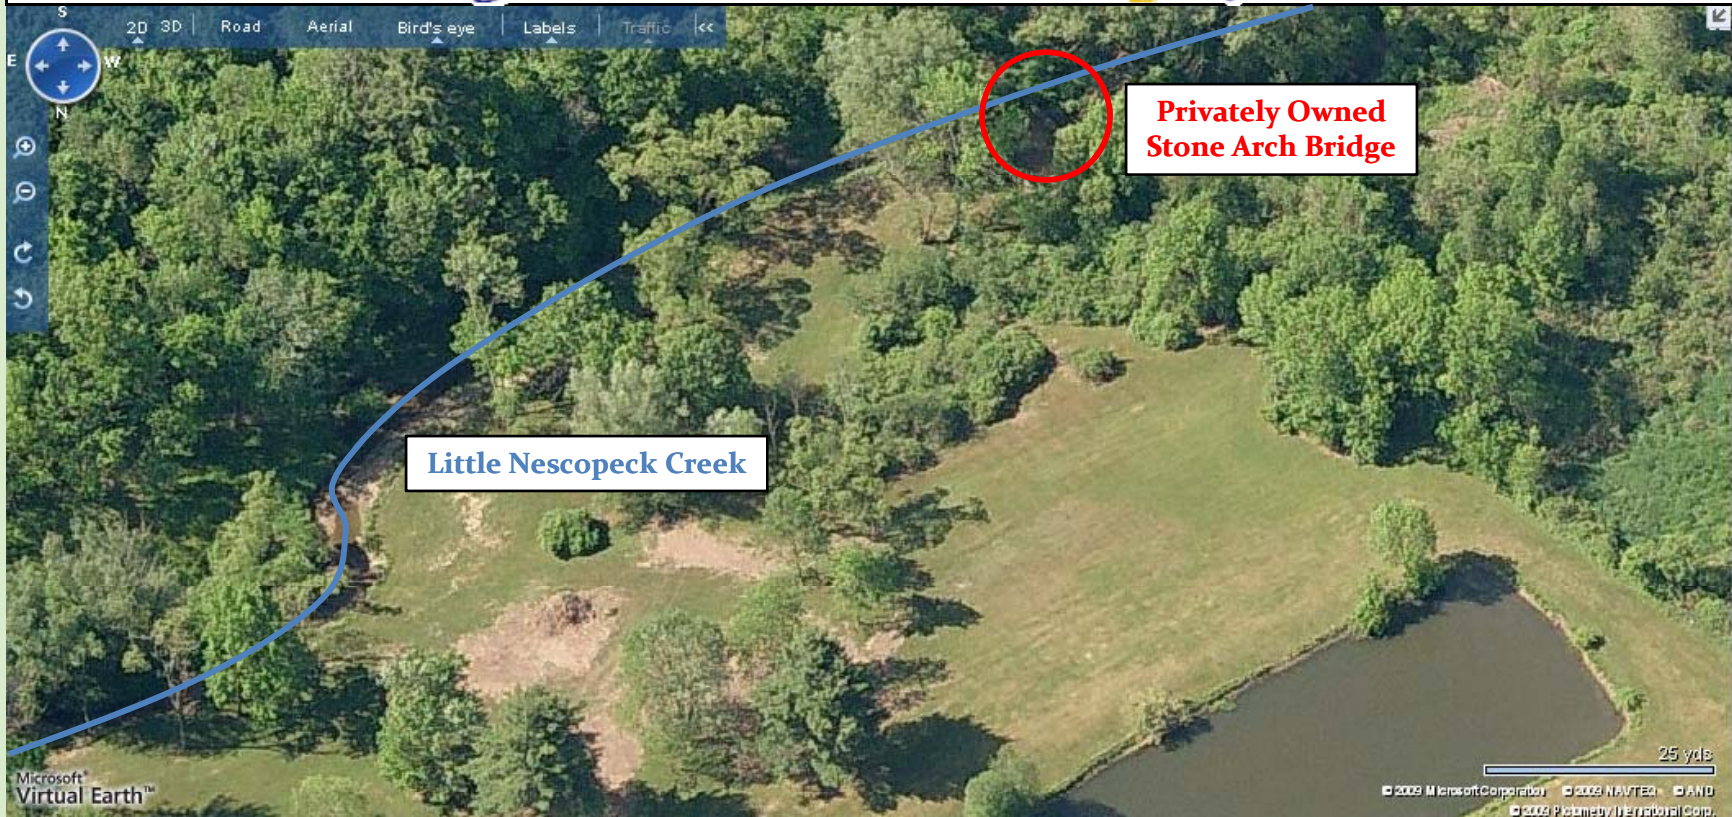
Problem Area	Municipality	Sub Watershed	Stream Name	Preferred Solution
BU001	Butler Twp	Nescopeck	Little Nescopeck Creek	Proposed Solution (N/A)

Explanation: The Luzerne Conservation District stream bank erosion at this location. The little Nescopeck passes behind a private residence that includes a privately owned stone arch bridge, which appears to be undersized. This problem appears to have been corrected with the channel lined with riprap upstream of the bridge.

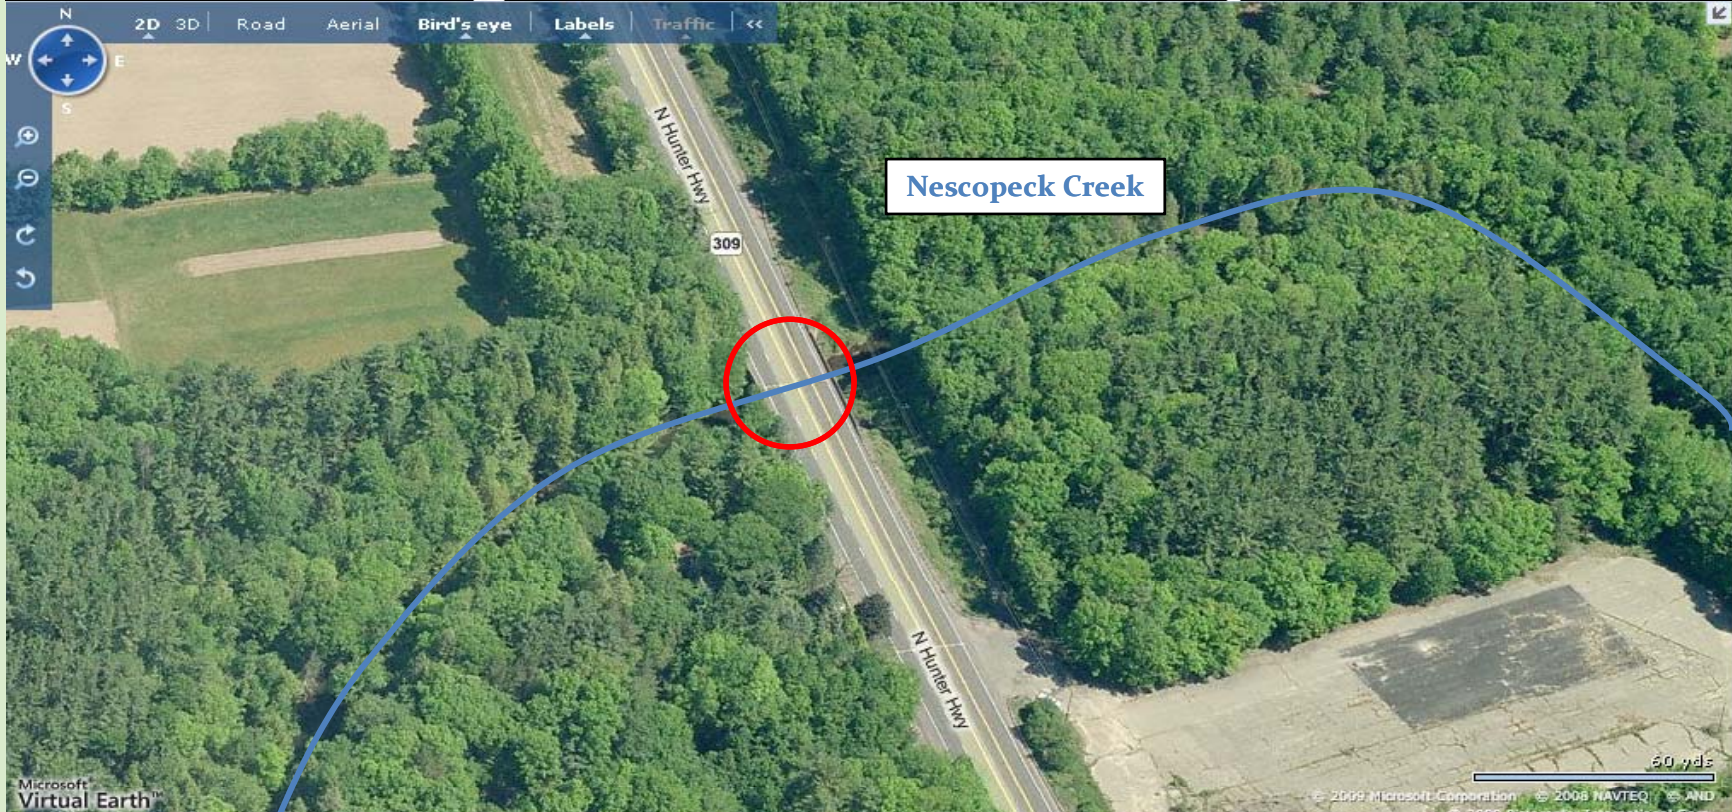
Problem Area	Municipality	Sub Watershed	Stream Name	Preferred Solution
BUToo2	Butler Twp	Nescopeck	Nescopeck Creek	Proposed Solution (B)

Explanation: The two span bridge carrying Rt. 309 over the Nescopeck Creek has flow though only the northern span due to sedimentation. Additionally fallen trees caused by erosion block the flow upstream of the bridge. Options for correction include clearing the sediment under the southern span and removing the fallen trees.

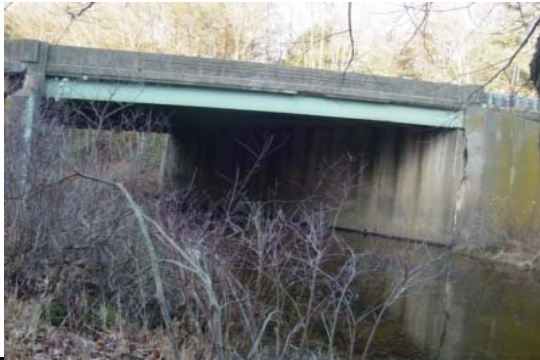
Problem Area ID:	BUT002	Inspected By/Date:	PAK 12/3/2008
Municipality:	Butler Township	Checked By/Date:	DEW 2/4/2010
Subwatershed:	Nescopeck Watershed

Stream name:	Black Creek		
Drainage Area (mi ²):	47.4		
Calculation Method:	NSS StreamStats		
C (Tc):	N/A (N/A)		
Storm Frequency (Yrs)	Rainfall (in)	Peak Discharge (cfs)	Unit Discharge (cfs/Ac)
2	N/A	1,680	0.06
5	N/A	2,840	0.09
10	N/A	3,760	0.12
50	N/A	6,250	0.21
100	N/A	7,510	0.25
500	N/A	11,000	0.36
*Type of Problem (Highlight all that apply):		Description	
Flooding	Deficient Bridge/Culvert	Stream bank erosion upstream of 309 bridge, tree root exposure, and sediment deposition under the bridge were observed.	
Erosion	Sedimentation		
Water/Groundwater Pollution	Other		
Potential Solutions			
<p>The Route 309 Bridge over Nescopeck Creek has been identified as a problem area by the Conservation District due to a history of debris accumulation and sedimentation. Based upon general field observations, this problem is believed to be caused by accumulation of sediment and debris under the southern span causing an obstruction of flow. Possible solutions to this problem are A) restore and stabilize stream bank upstream of the bridge B) provide more frequent maintenance activities to remove sedimentation under bridge.</p>

Cost Estimates			
Option	A	B	C
Cost Range	\$25,000-\$50,000	\$5,000-\$10,000/year	N/A

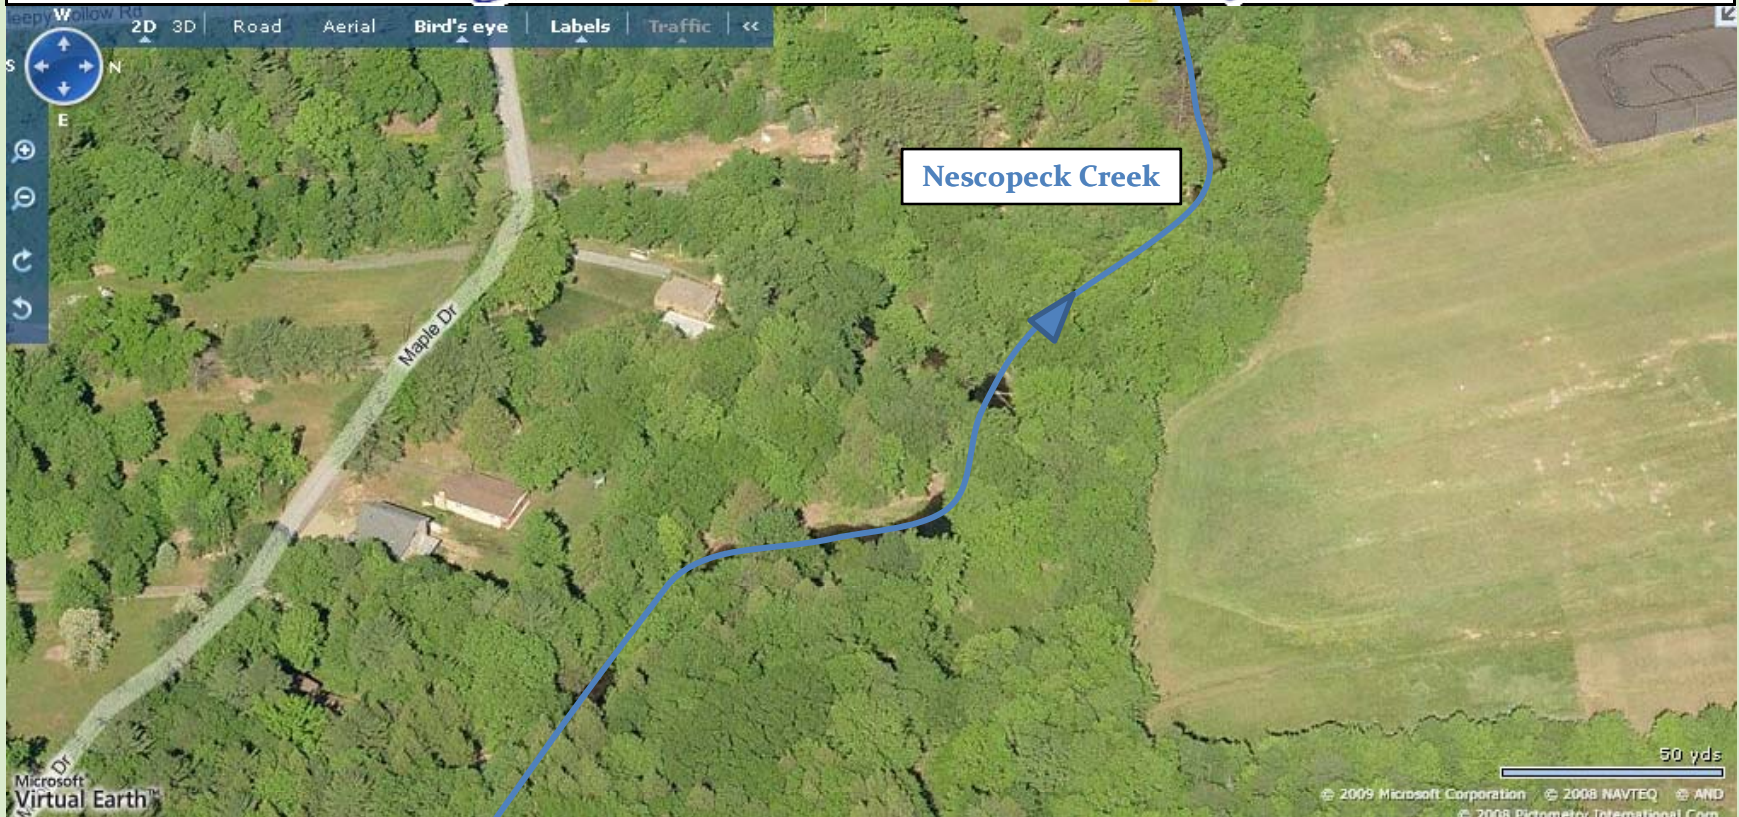
Problem Area	Municipality	Sub Watershed	Stream Name	Preferred Solution
BU003	Butler Twp	Nescopeck	Nescopeck Creek	Proposed Solution (B)

Explanation: The Conservation District reports that houses located along Maple Dr. are experiencing flooding. Additional issues include stream erosion and what looks to be insufficiently-sized conveyance systems. Options for correction include construction of a floodwall or levee, floodproofing the houses, or changing the stream configuration to allow more flow to be carried within the banks.

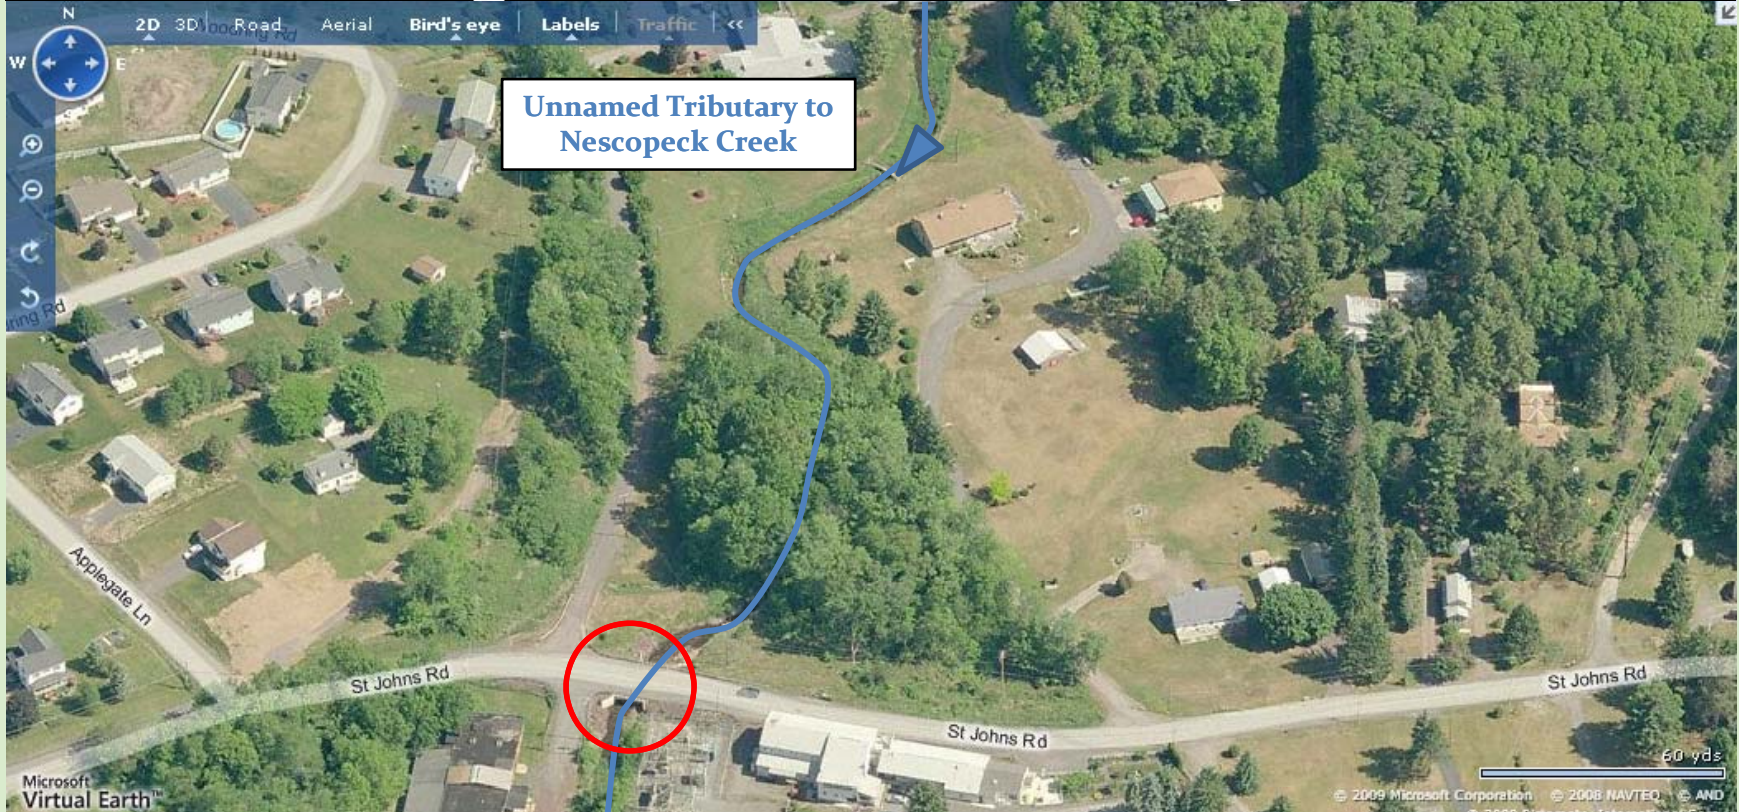
Problem Area	Municipality	Sub Watershed	Stream Name	Preferred Solution
BU004	Butler Twp	Nescopeck	Trib to Nescopeck Creek	Proposed Solution (B)

Explanation: The Conservation District reports that this problem extends from the culvert at St. Johns Road to Rumble Dam. Based on preliminary hydraulic calculations, the channel appears undersized to convey runoff from significant rainfall events. Options for correction include removal of debris from the stream channel and changing the stream configuration to allow more flow to be carried within the banks.

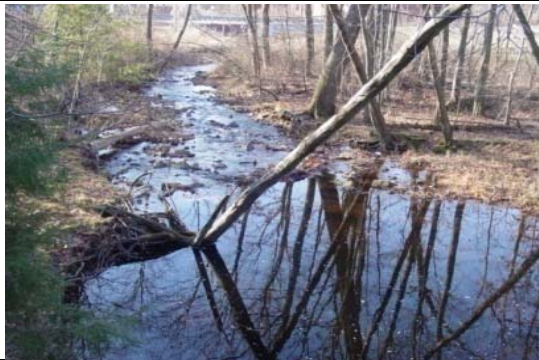
Problem Area ID:	BUT004	Inspected By/Date:	PAK 12/3/2008
Municipality:	Butler Township	Checked By/Date:	DEW 2/4/2010
Subwatershed:	Nescopeck Watershed

Stream name:	Trib to Nescopeck Creek		
Drainage Area (mi ²):	4.75		
Calculation Method:	USGS 2000-4189		
C (Tc):	N/A (N/A)		
Storm Frequency (Yrs)	Rainfall (in)	Peak Discharge (cfs)	Unit Discharge (cfs/Ac)
2	N/A	423	0.14
5	N/A	565	0.19
10	N/A	675	0.22
50	N/A	1,207	0.40
100	N/A	1,498	0.49
500	N/A	2,355	0.77
*Type of Problem (Highlight all that apply):		Description	
Flooding	Deficient Bridge/Culvert	Houses built along the tributary appear to be built within the floodplain. Bank erosion is present upstream of the culvert under St. Johns Road.	
Erosion	Sedimentation		
Water/Groundwater Pollution	Other		
Potential Solutions			
<p>Repeated flooding at private residences north of St. Johns road along a tributary to Nescopeck Creek have been identified by the Conservation District. Based upon general field observ., this problem is believed to be caused by a structures constructed in the floodplain with floor elevation below the flood elevation, which has resulted in flood damage. Possible solutions to this problem are A) to remove debris from the stream channel, or B) changing the stream configuration to allow more flow to be carried within the banks.</p>

Cost Estimates			
Option	A	B	C
Cost Range	\$5,000	\$10,000-\$30,000	N/A

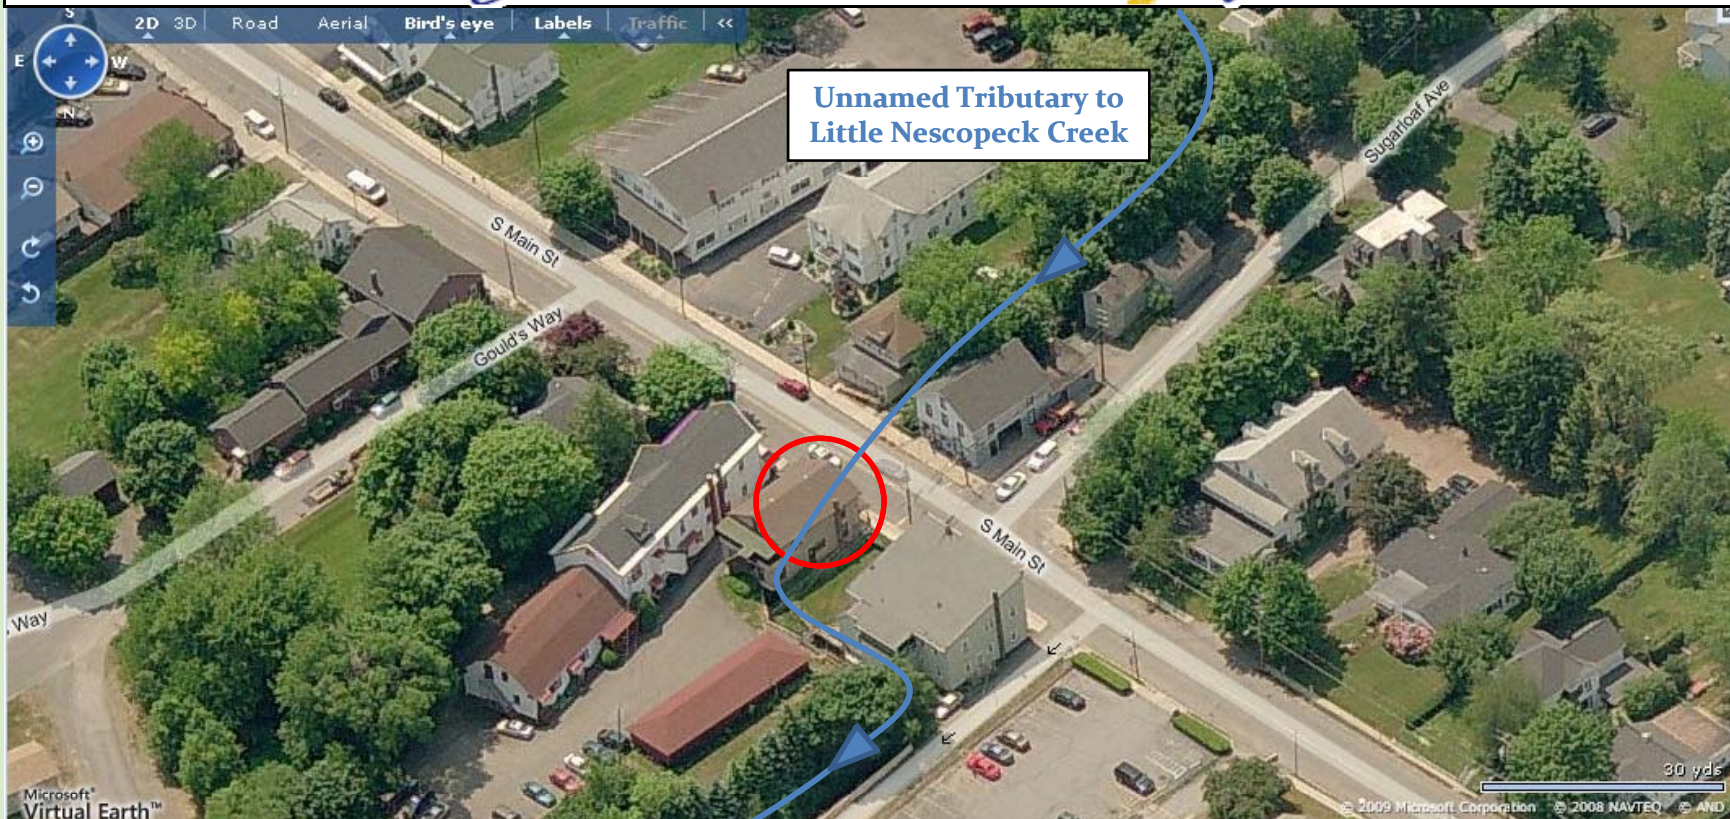
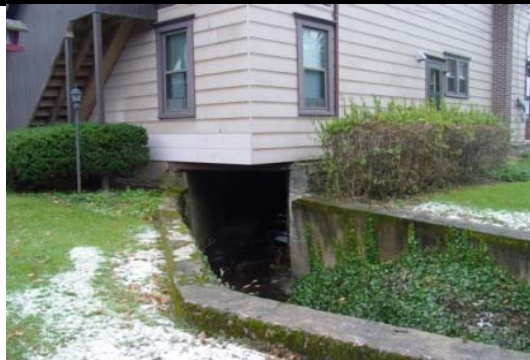
Problem Area ID:	CNB001	Inspected By/Date:	PAK 11/26/2008
Municipality:	Conyngham Borough	Checked By/Date:	DEW 2/5/2010
Subwatershed:	Nescopeck Watershed

Explanation: This is the same reach from Problem Areas CNBoo4, CNBoo5, CNBoo6, and CNBoo10. Due to development within the floodplain, a number of different problems have arisen. These include flooding, erosion, and water quality issues. Due to the complexity of the problem and the configuration of the existing conveyance, an in-depth analysis is required to see what the impact removal of the house, reestablishing the buffer, or altering the channel would have upon the tributary as a whole.

Stream name:	Trib to Little Nescopeck		
Drainage Area (mi ²):	0.6		
Calculation Method:	USGS 2000-4189		
C (Tc):	N/A (N/A)		
Storm Frequency (Yrs)	Rainfall (in)	Peak Discharge (cfs)	Unit Discharge (cfs/Ac)
2	3.16	121	0.32
5	3.91	192	0.50
10	4.57	270	0.70
50	6.53	339	0.88
100	7.63	419	1.09
500	10.98	652	1.70
*Type of Problem (Highlight all that apply):		Description	
Flooding	Deficient Bridge/Culvert	At this location, the channel travels under a house, makes two 90 degree bends within 100 feet of one another, and is eroding. Due to its location, the structure is subject to regular flooding.	
Erosion	Sedimentation		
Water/Groundwater Pollution	Other		
Potential Solutions			
<p>A multitude of problems along the tributary that passes under S. Main St. have been identified by the Municipality. Based upon general field observations, these problems are believed to be caused by a structure constructed in FEMA floodplain with floor elevation below flood elevation. Possible implications are flooding, property damage, road closures, and eventual structure failure. Due to the complexity of the problem and configuration of existing conveyance, a more in-depth analysis of the problem area is required. Analysis should consider removal of the house with the culvert under it and reestablishment of the floodplain.</p>

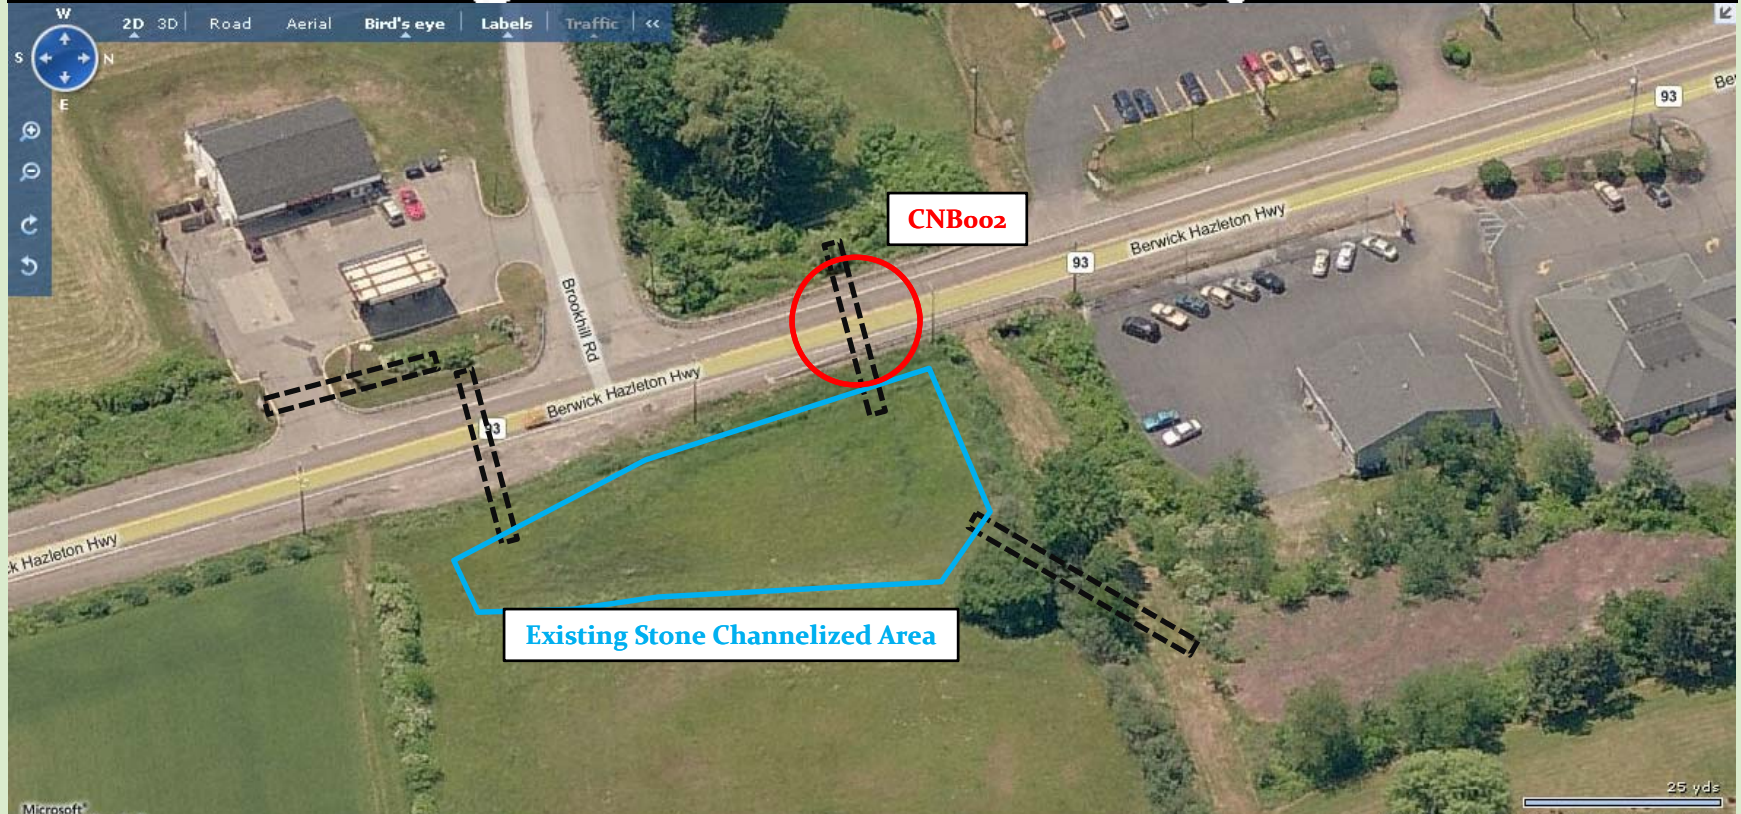
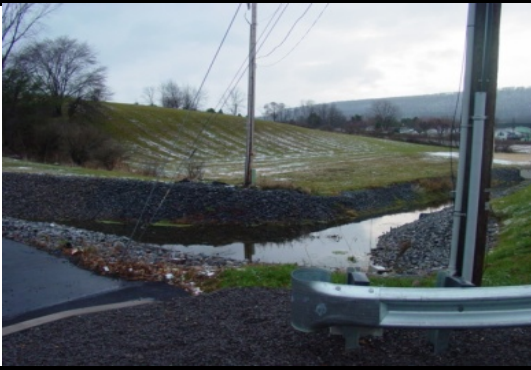
Problem Area ID:	CNB002	Inspected By/Date:	PAK 11/26/2008
Municipality:	Conyngham Borough	Checked By/Date:	DEW 2/5/2010
Subwatershed:	Nescopeck Watershed

Explanation: This problem located along Route 93 appears to have recently been modified. A stone channel has been placed as well as new culverts leading to it. The culvert at CNBoo2 appears to be causing some erosion issues near the inlet. Options for correction involve stabilizing the banks as well as removing the silt fence.

Stream name:	Trib to the Little Nescopeck Creek		
Drainage Area (mi ²)	0.56		
Calculation Method	USGS 2000-4189		
C (Tc)	N/A (N/A)		
Storm Frequency (Yrs)	Rainfall (in)	Peak Discharge (cfs)	Unit Discharge (cfs/Ac)
2	3.40	102	0.28
5	4.22	142	0.40
10	4.95	169	0.47
25	6.10	248	0.69
50	7.16	319	0.89
100	8.43	406	1.13
*Type of Problem (Highlight all that apply):		Description	
Flooding	Deficient Bridge/Culvert	Runoff is directed into a culvert system along SR 93. North of the intersection of SR 93 and Brookhill Road is a new culvert. Erosion is occurring on the west side of SR 93 and there are low points on the East side which result in ponding condition.	
Erosion	Sedimentation		
Water/Groundwater Pollution	Other		
Potential Solutions			
Erosion and flooding problems at this location has been identified by the Conservation District. Based upon general field observations, this problem is believed to be caused by unvegetated/stabilized areas and areas with little or no slope. Possible solutions to this problem are A) stabilization with seeding and erosion control blankets and grading of swales/depressions to promote positive drainage. Detailed topographic surveying would be needed to determine the feasibility of regrading.
